# HOW DESIGN QUIRKS AND CONDITIONS OF USE CONSPIRE TO STRUCTURAL FAILURE – A CASE STUDY

W. Ost<sup>1</sup>, J. Van Wittenberghe<sup>1</sup> and P. De Baets<sup>1</sup>

<sup>1</sup> Ghent University, Laboratory Soete, Belgium

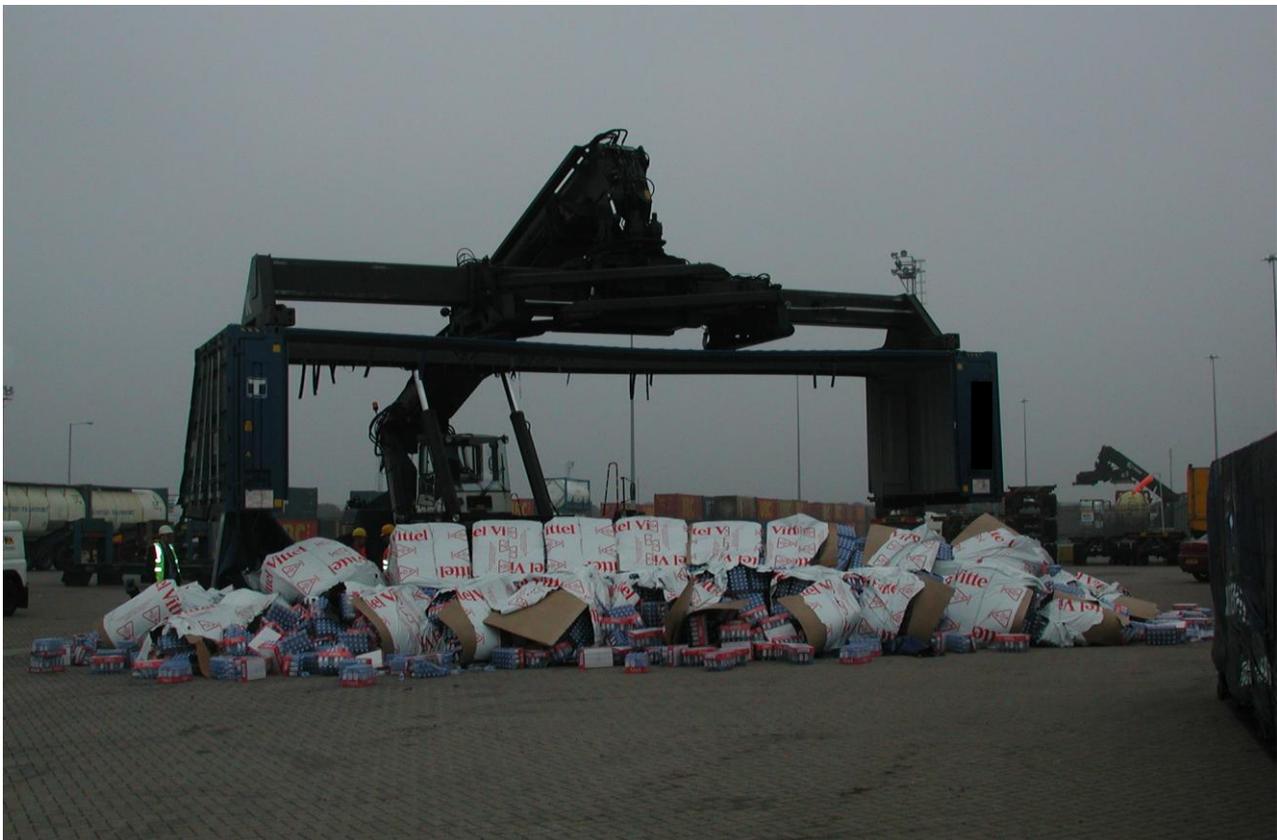
Figure 1. Overview of the failed freight container

During the handling of a 45ft. container loaded with about 20 tons of bottled mineral water the floor of the container gave way, spilling its contents on the quay floor (see figure 1). The container was not the standard type with corrugated sheet metal sides, but a so called “curtain sider” container in which both sides of the container were equipped with sliding curtains, enabling the easy loading and unloading of the container.

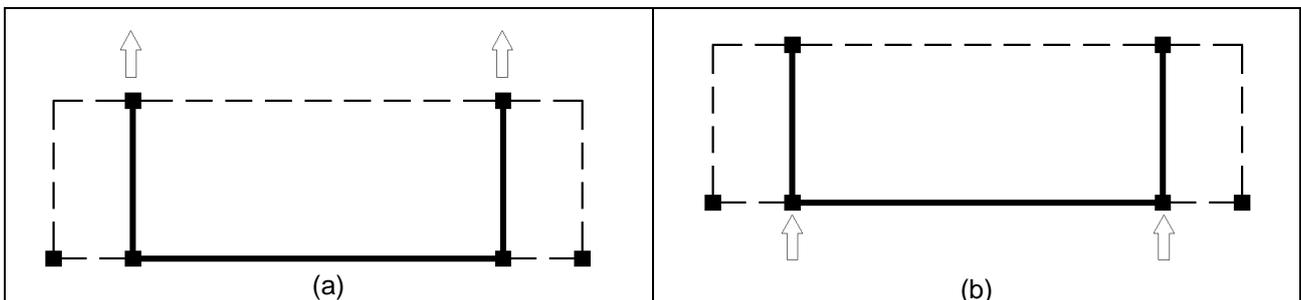
When lengthening the design of the container from 40ft. to 45ft. the designer considered that the freight container would be handled mostly with the original castings interspersed by 40ft. (see figure 4). Consequently the extra 2.5ft. of container floor added at the front and the back were manufactured considerably weaker (and lighter) than the original 40ft. container floor in between. To make lifting the container at the 40ft. castings possible the steel doors were strengthened with a vertical girder and equipped with pins at the bottom and at the top of the door, which engaged with the 40ft. castings in the roof and the floor of the container, thus transferring the weight placed on the floor towards the 40ft. castings in the roof.

Figure 4. Loading situation considered in the design (a) lifting at the 40ft. castings (b) supported at 40ft. castings.

This means that the 2.5ft. floor additions at both ends of the container can be carrying the full weight of the freight in the container and that the design assumptions of figure 4 are erroneous. The load cases shown in figure 11 should have been considered in the design stage.

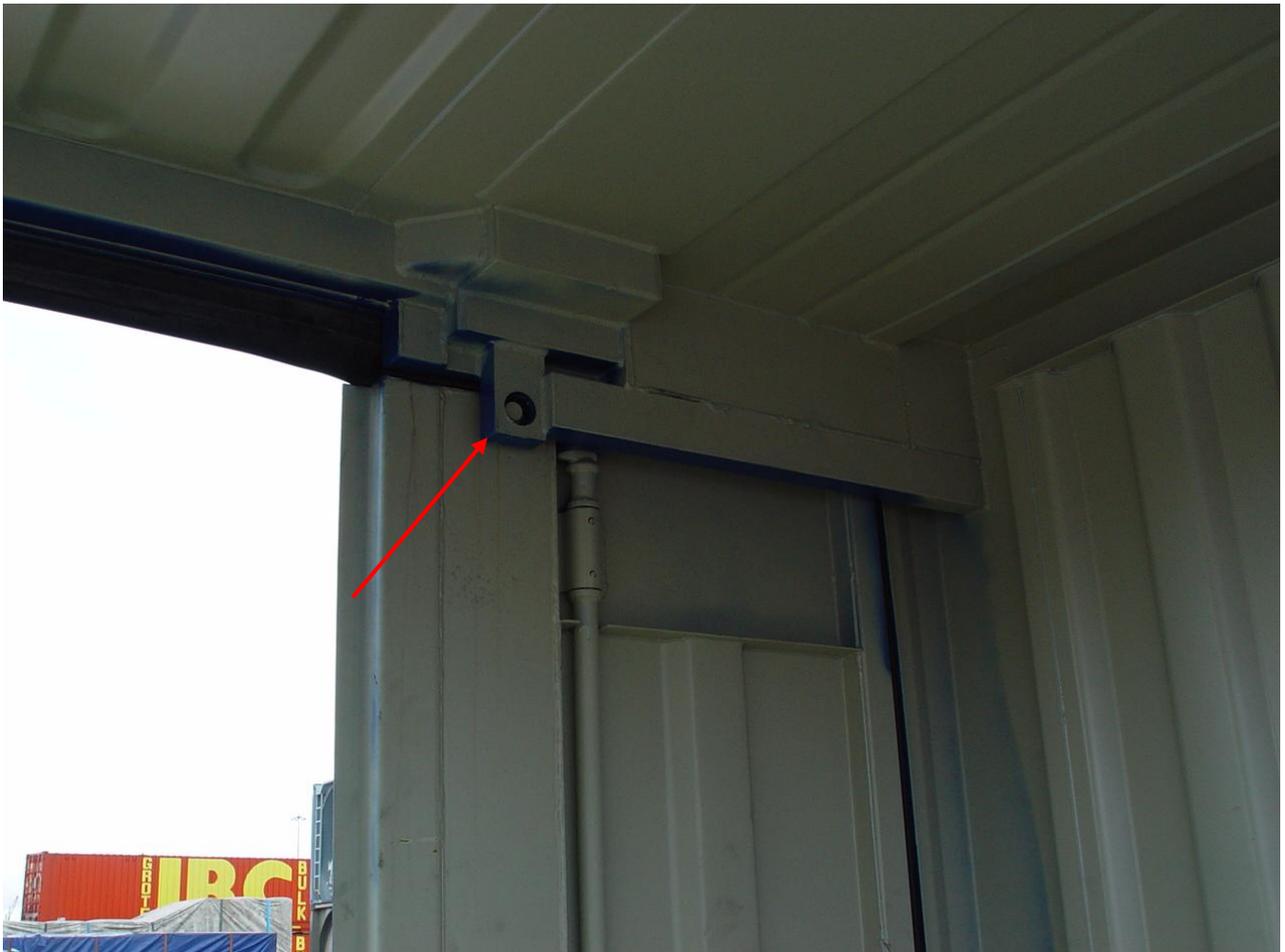
The accident occurred when the container was lifted from the top at the 40ft. castings (see figure 1). Initially some concerns were raised whether the side doors were closed and locked when the container was lifted from the top. The operator of the handling equipment was adamant that the side doors were closed. This was backed up by pictures taken immediately after the accident showing that the doors (which weren't wrenched open in the accident) were still closed and that the pins at the top of the door were still engaged with the castings (see for example figure 5).

Figure 5. Top of one of the side doors (view from inside container) showing the top pin still connected to the 40ft. casting.

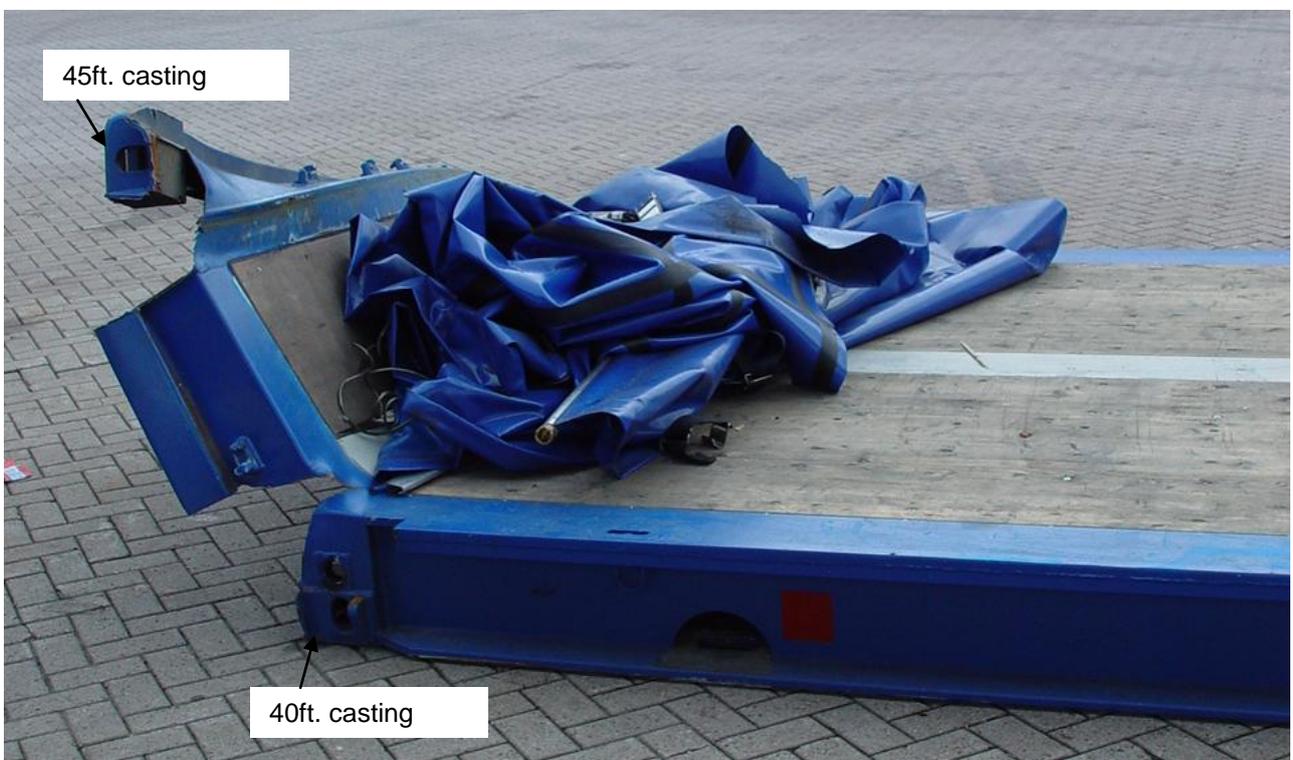
Nevertheless the way in which the container floor failed at the back side of the container (see figure 6) clearly indicate the side doors failed before the floor dropped out of the container. The 2.5ft. floor addition is twisted upwards and the beams in the floor are halfway torn from the 40ft. and 45ft. castings.

Figure 6. View of the back of the floor.

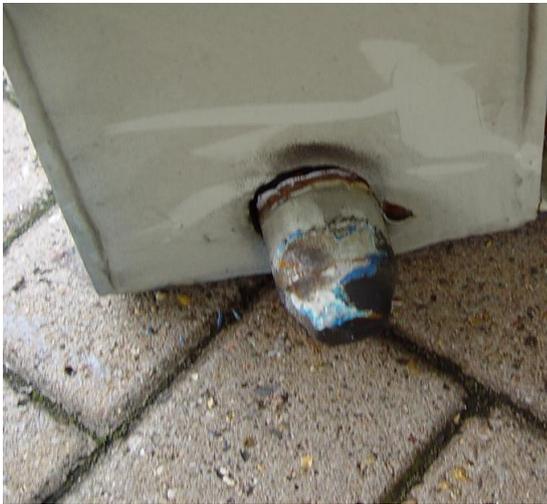
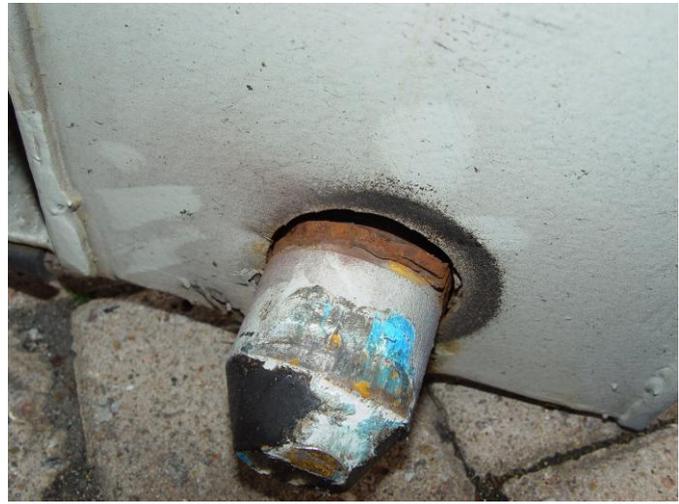
The reason for this became evident when the doors were inspected. The pins connecting the bottom of the doors to the 40ft. castings in the floor of the container were badly bent. Something similar occurred to the pins of the side doors at the front of the container: the bottom pin of the right side door was missing and the bottom pin of the left side door was badly bent. Corrosion of the fracture faces indicated that the tears at the connection of the bottom pins to the doors shown in figure 6(b) had occurred sometime prior to the accident. Similar corrosion on the fracture surface of the missing pin shown in figure 7 proved that this pin had already gone missing before the accident, explaining the fact that this pin could not be retrieved at the site of the accident.

Figure 6. View of the bottom pins at the of the side doors at the back of the container: (a) bottom pin of right side door (b) bottom pin of left side door.

However this design flaw could be easily remedied by strengthening the connection of the pin to the door. But just locally strengthening the doors and the pins will not produce a good design. This is illustrated by the condition of another container which was in use on the quay. Figure 9 shows this container on a handling trailer. First notice that the floor of the 2.5ft. addition contains a large crack which will in a short

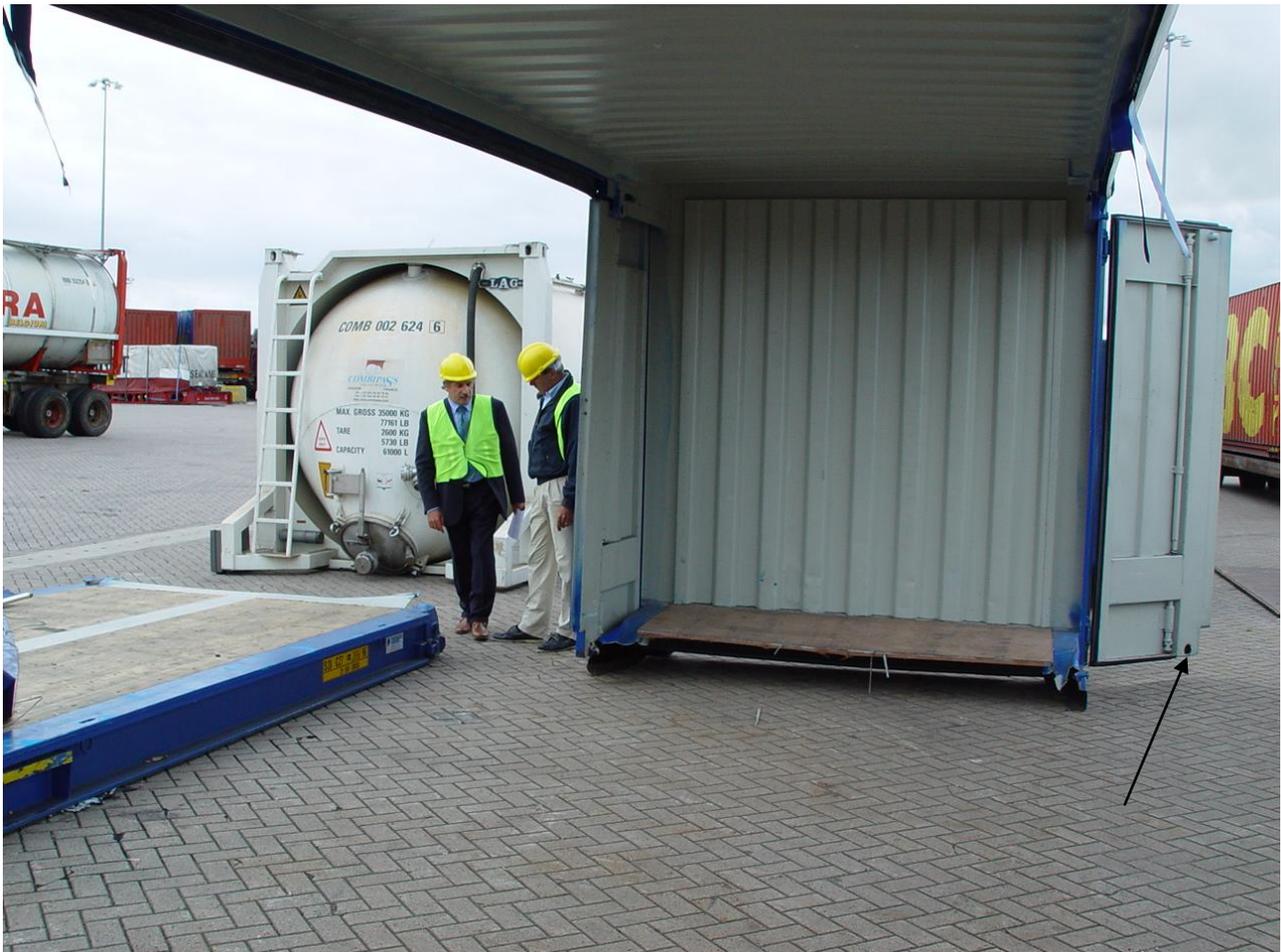
Figure 7. View of the front side of the container. Notice the bottom pin of the right hand side door is missing.

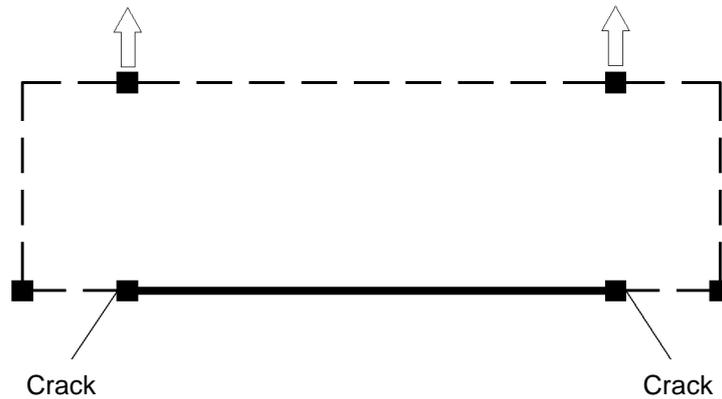
Due to the failure of the bottom pins of the doors transferred the load from the doors to the 2.5ft. addition on both ends of the container. As these additions were never designed to withstand this load they failed and the floor dropped out of the container.

Figure 8. Schematic overview of the condition of the container at the time of the accident. Due to pin failure the doors did not carry any load.

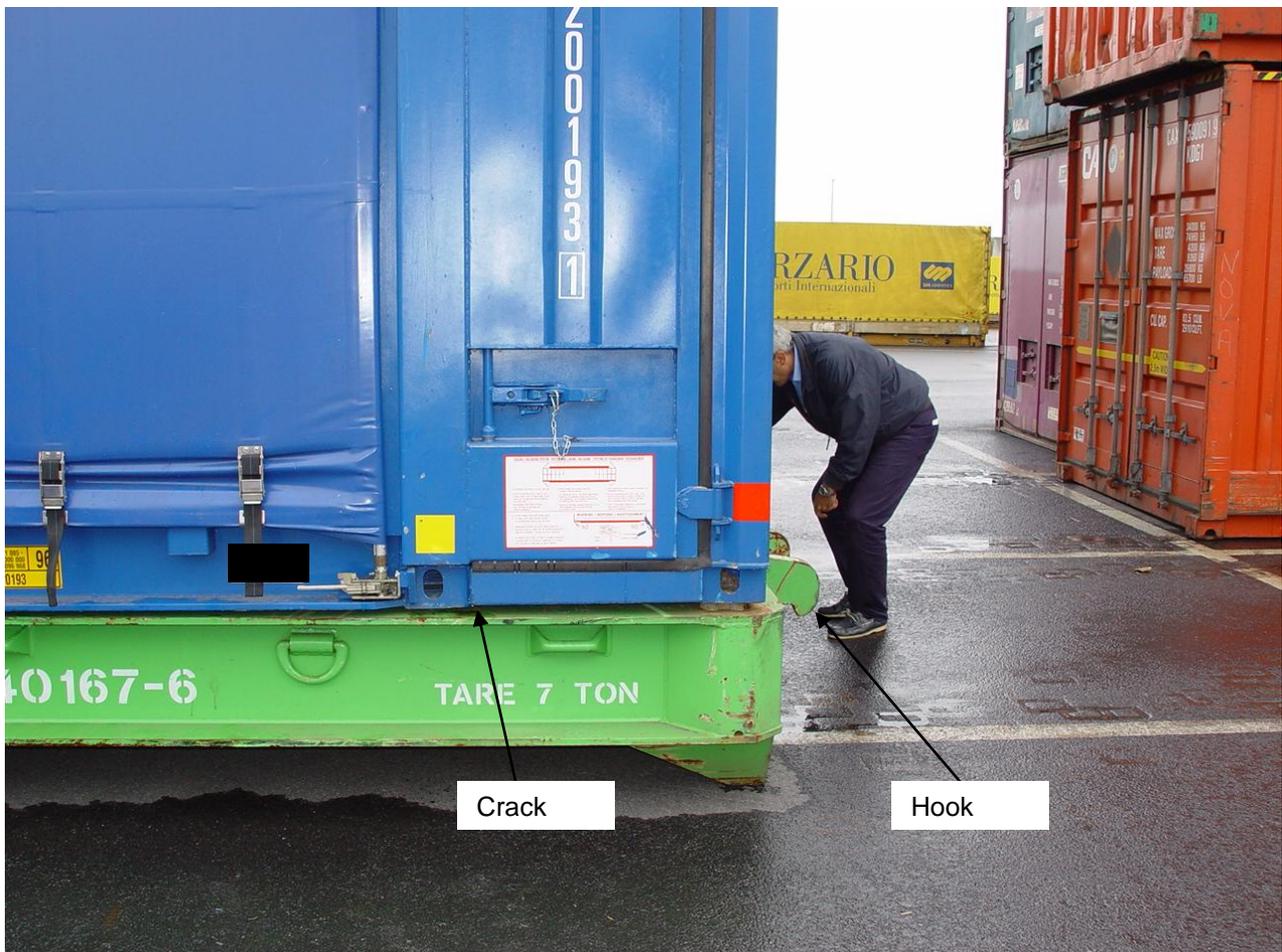
Figure 9. Side view of a similar container on a handling trailer – notice placement on the trailer so that hook is available.

time frame lead to failure (see detail in figure 10). Secondly notice the placement of the container on the handling trailer. The hook at the front of the handling trailer needs to be available to lift this end of the trailer off the ground.

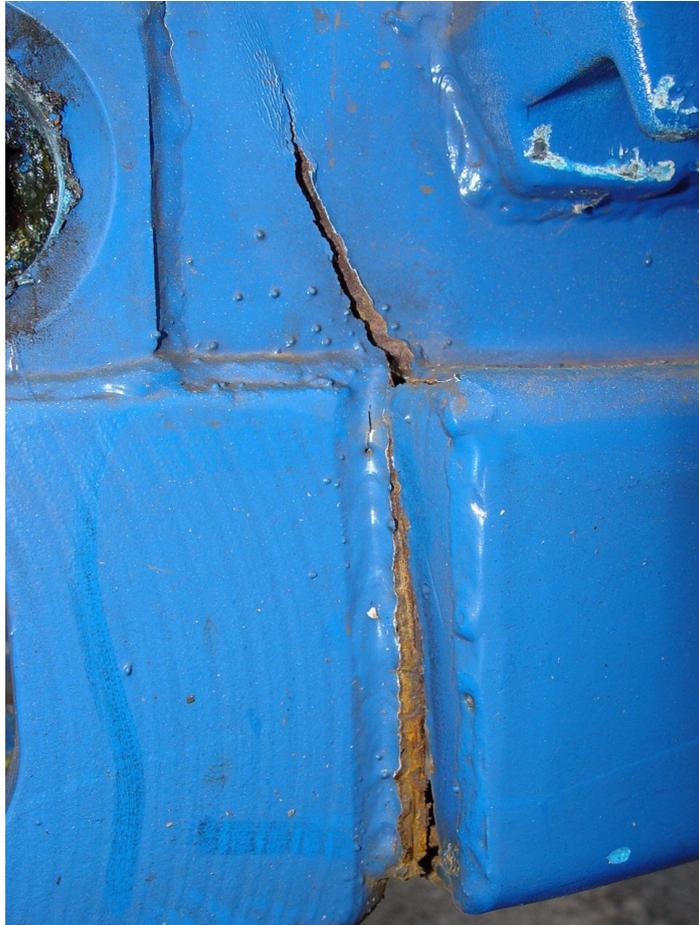
Figure 10. Detail of crack in floor beam of 2.5ft. addition just next to 40ft. casting.

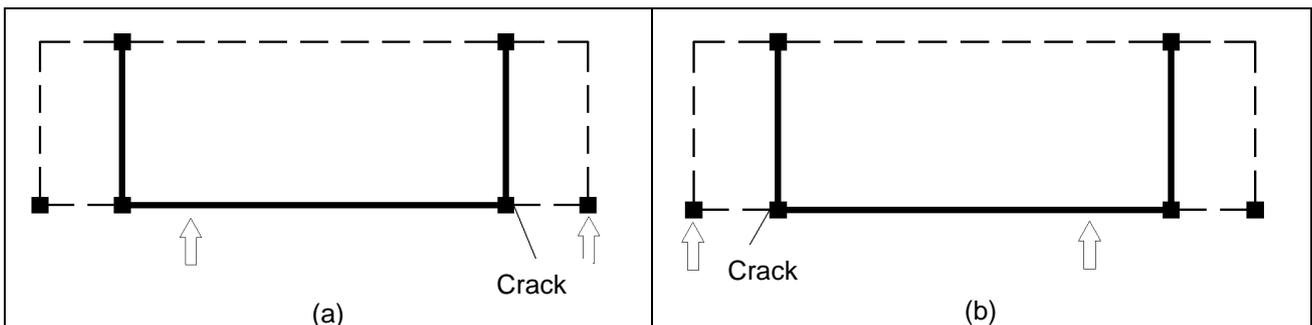
Figure 11. Load situation when the 45ft. freight container is placed on a 40ft. handling trailer. Container will overhang the trailer by 5ft. at one end.
