# HOW DESIGN QUIRKS AND CONDITIONS OF USE CONSPIRE TO STRUCTURAL FAILURE – A CASE STUDY

W. Ost<sup>1</sup>, J. Van Wittenberghe<sup>1</sup> and P. De Baets<sup>1</sup>

<sup>1</sup> Ghent University, Laboratory Soete, Belgium

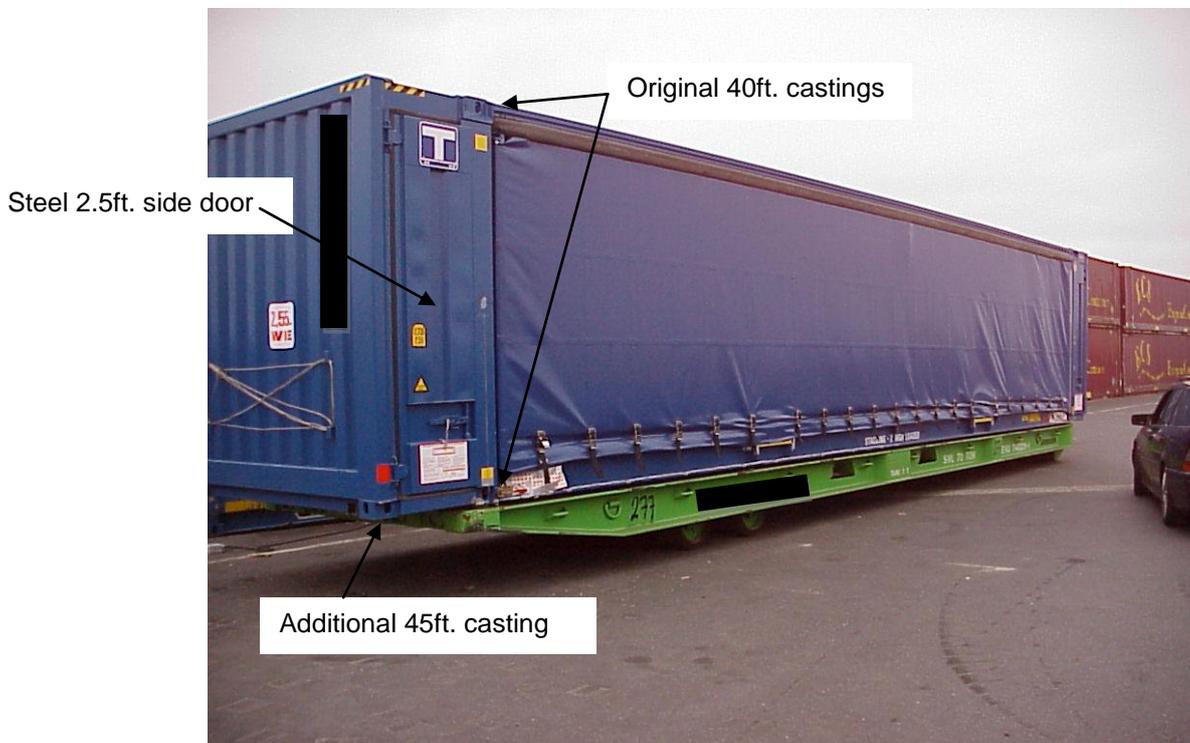
This resulted in the design shown in figure 2 and 3. In these figures the freight container is shown on a 40ft. handling trailer called a “MAFI” after the company manufacturing these trailers;

Figure 2. View from the front of a container of the same type, on a 40ft. handling trailer.

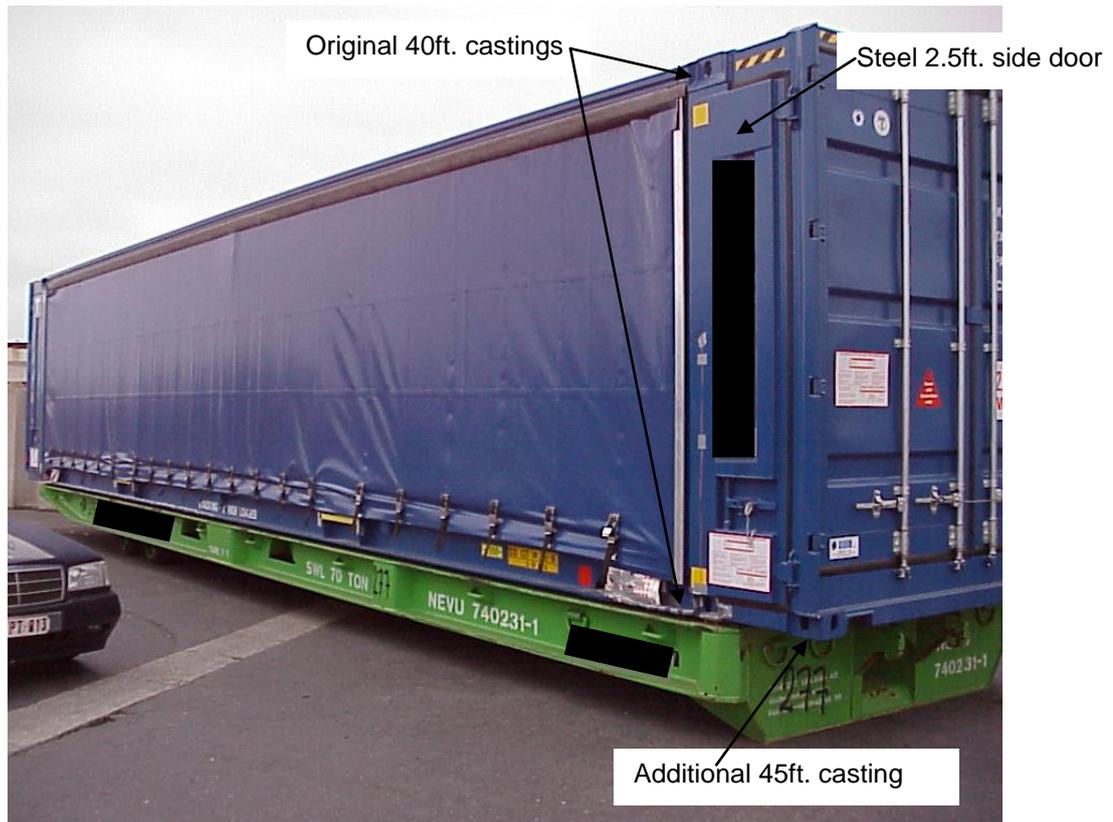
Due to this design strategy the weight of the container could be limited (the front and back 2.5 floor and roof additions were relatively light). However there was some danger inherent to this design – as the girders in the doors carried the load placed on the floor the doors should always be closed when lifting the container from the top. To notify handlers of this a warning sign to this effect was placed on all four doors.

Figure 3. View from the back of a container of the same type on a 40ft. handling trailer
