## FAILURE BEHAVIOUR OF A TUMBLE DRYER

**Abstract** A tumble dryer is a rotating heated vessel used to fulfil a poly-condensation process of PET-granules. This step is very crucial in the entire production process of polymer fibres. System failure, causing production loss, cannot be afforded. Unfortunately, since a couple of years, the reactors suffer from severe cracking at weld details. To find the root cause(s) of this problem a detailed study of the vessel construction, the loads induced during the production process and the cracking has been performed. Hereby the influencing parameters and their importance could be determined. Based on this study it is put forward that fatigue, due to the exceptional translation of the granules in the vessel, is responsible for the cracking of the tumble dryer. Two main loading modes and corresponding crack locations could be determined: a cyclic changing torque causes the cracks on the outside of the vessel while the dynamic play of the moving granules around the heating elements is responsible for the cracks at the inside the tumble dryer. The root cause of the cracking problem has been determined but the actual mechanism causing the cracks

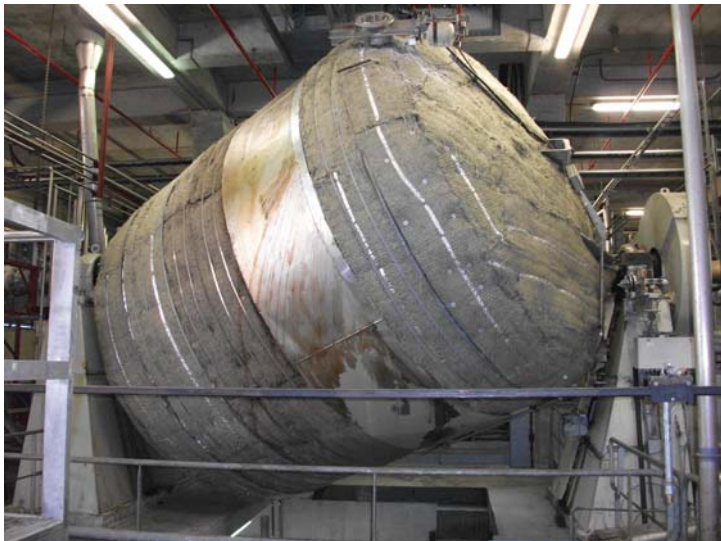
Figure 1: One of the four tumble dryers (capacity of 44m<sup>3</sup>) at the Spinning Division of Sioen Fibres.

A tumble dryer (Figure 1) is a patented device which is used in the polymer fibre industry. Polymer fibres are produced from PET-chips. However, before this material can be used for the production of fibres, the PET-chips have to undergo a heat treatment which is called a post-condensation process. This is the process that is taking place inside the tumble dryer. During this treatment all impurities are removed and the viscosity of the chips is adapted to meet the requirements of the subsequent process steps.

Four tumble dryers of this type are continuously in operation at the Spinning Division of Sioen Fibres (Moeskroen, Belgium) to meet the production demand. In the year 2000 the first two smaller units, with a capacity of 36m<sup>3</sup>, have been installed. In 2003 there was a production expansion with 2 bigger units each having a capacity of 44m<sup>3</sup>. Initially the tumble dryers operated well. As of 2007 the first problems in one of the vessels emerged. At random locations cracks were found in different crucial welds, both at the inside and outside of the vessel. These cracks were systematically resolved but the problem continuously shifted to other sections of the vessel. Constructional adaptation by the supplier did not solve the problems, on the contrary they even worsened the situation. Eventually they even had to

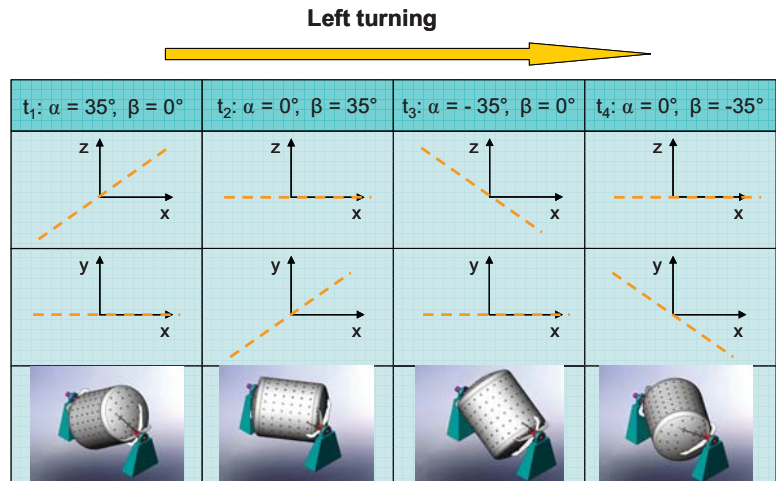
Figure 10: Evolution of the vessel's position

It can be concluded that the introduced system makes it possible to describe unequivocally the vessel's position at any time. Figure 10 shows how the position of the tumble dryer changes during its rotation.

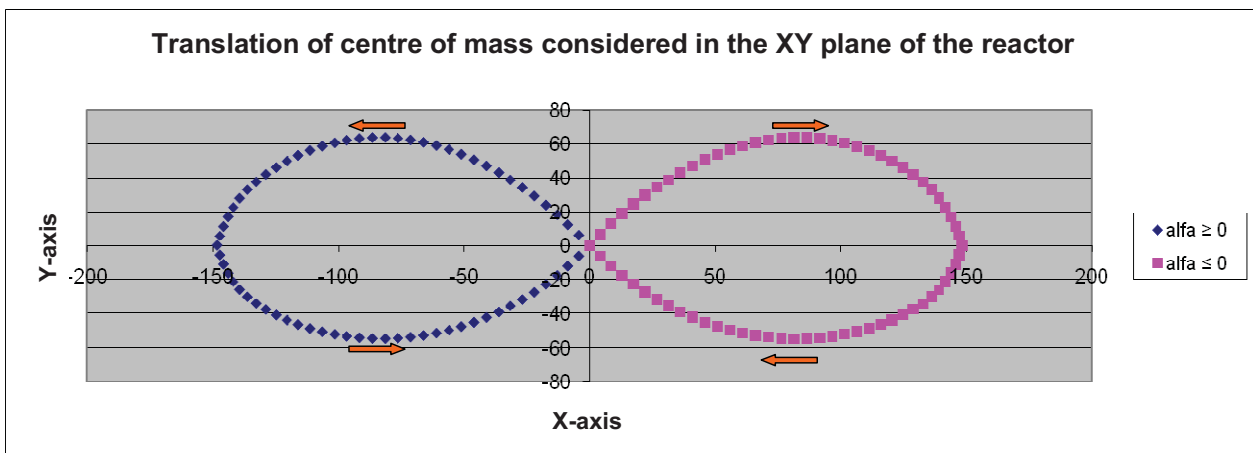
Figure 11: Translation of centre of mass considered in the XY plane of the reactor

To determine the influence of the weight and movement of the PET granules, we need another approach. Studying the process on figure 3 reveals that the position of the chips' centre of mass is not displaced symmetrically during the rotational movement. Because the vessel is not filled completely, the centre of mass  $M$  will follow a 3 dimensional curve through the vessel. To study this phenomenon we need to know the location of  $M$  for every position of the vessel (determined by alpha and beta). The results of these calculations are presented in Figure 11.

It is clear that during one rotational movement the centre of mass describes a “horizontal figure 8” in the XY-plane. This implies that during one rotation the torque-rate changes 4 times. If the Y-coordinate of  $M$  has a positive value, the torque is reinforced while a negative value for  $Y_M$  results in a drop of the torque. The periodical change of torque in time can be expressed as:

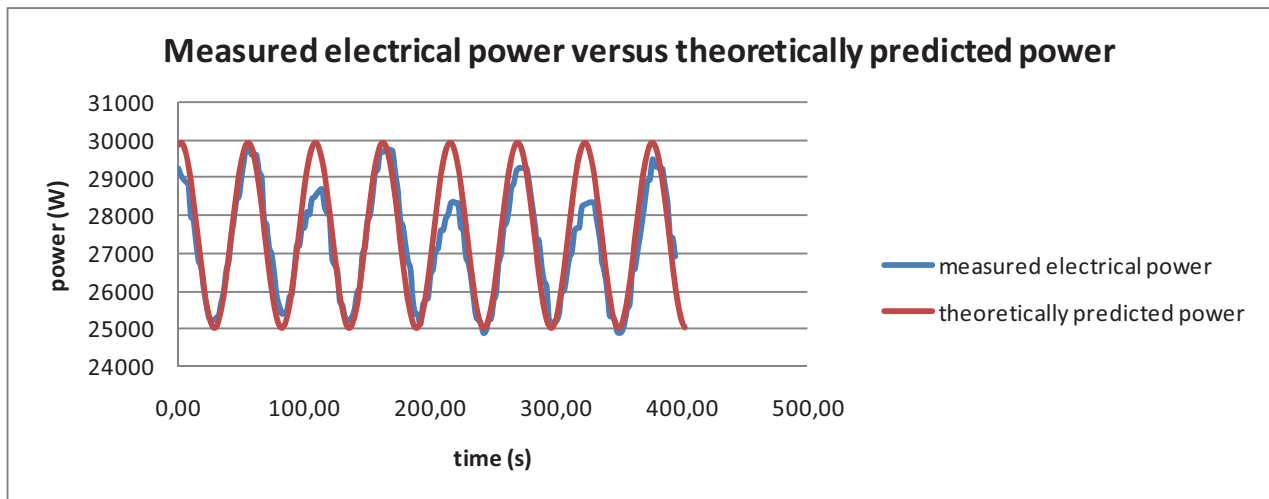
Figure 12: Measured electrical power versus theoretically predicted power

To verify these results, an electrical power measurement of the driving motor has been performed (Figure 12). The calculated profile is adapted with a factor  $C=0,25$  to match with the measurements. This correction was necessary because the flow behaviour of water differs from the behaviour of solid particles due to: friction, bulk density, dilatancy, shape of the particles etc. So we can conclude that the mass displacement of the granules generates a dynamic change of the driving torque. This effect is expected to have a serious impact on the tumble dryers' fatigue endurance live.
